## KENTUCKY INDIVIDUAL BUILDING SURVEY FORM

1. NAME OF RESOURCE (how determined): 1 / Original owner or builder Rose Maureen Faulkner House	17. PLAN: First: O / Other (specify) open plan Second: _____

2. ADDRESS/LOCATION: 508 Center Street Berea, KY 40403	18. STYLISTIC INFLUENCE: First: 7:Y: Contemporary Second: _____
3. UTM REFERENCE: Quad Name: Berea, KY Date: 1993 Zone: 16 Method: G / GPS Unit Easting: 16S0740224 Northing: 4162188	19. FOUNDATION: Type: 2 / Continuous Material: C / Concrete Block

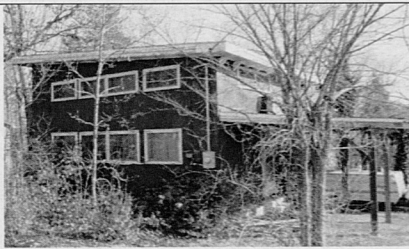
13. CONSTRUCTION DATE: Estimated 2: 1950-1974 Documented: 1958 (Berea College newsletter <i>The Pinnacle</i> )	COMMENTS/HISTORICAL INFORMATION: This house was designed by Maureen Faulkner, an English professor at Berea College, and built by Bill Swinford of Berea in October 1958. Maureen worked with Lester Pross, a well-known art professor at Berea College, on her designs. Lester Pross retired about fifteen years ago and is believed have built a model of the house. Although Maureen had developed two plans, one on the conservative side, Swinford agreed to build the 'little unusual one.' Faulkner, in a January 1960 article in <i>The Pinnacle</i> , described the house as "uncomplicated, compact, and relatively inexpensive" as well as being "about as small as a house can be, 24' X 24'." (cont - see cont sheet)

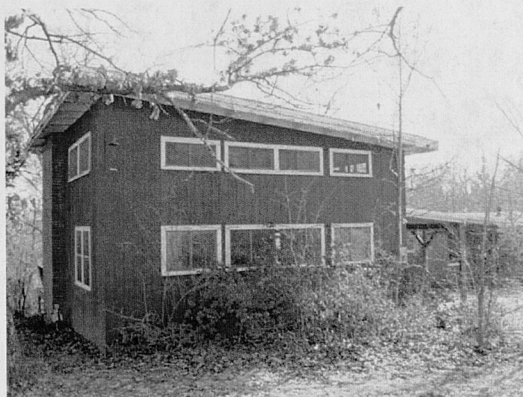
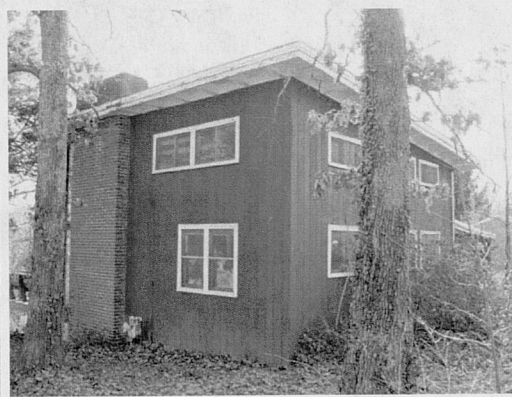
(Above-left) This is an E/N elevation showing the left side and façade of the house. Note the right side, shed roof porch with square-sided, braced wooden supports. This porch shelters the right side "front" door. (Above-right) This is an alternate E/N elevation showing more of the left side of the house including the wide, interior brick chimney which projects partially to the exterior.

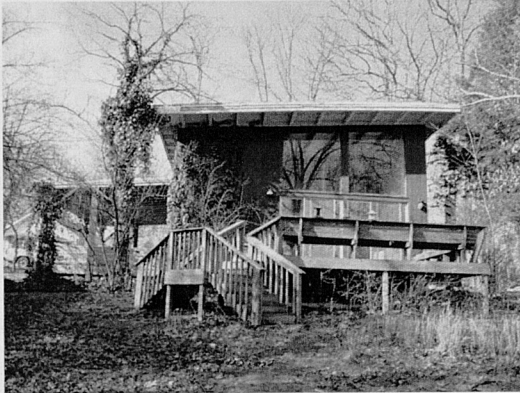
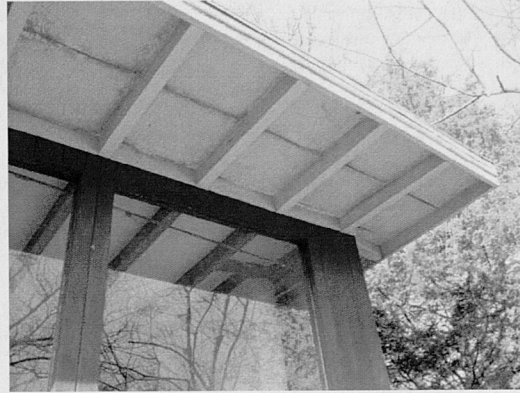
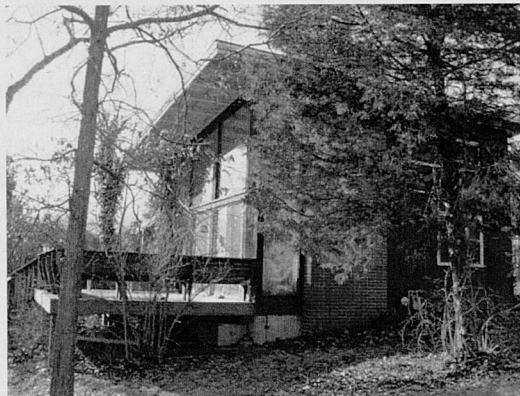
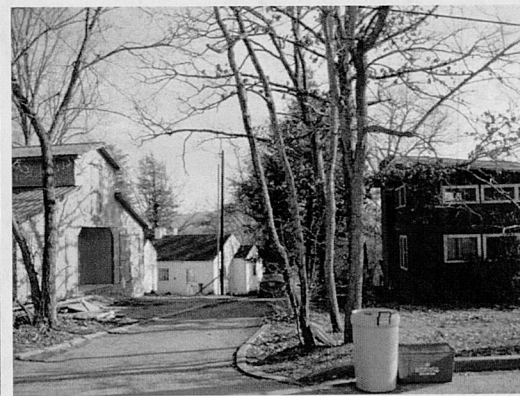
(Above-left) This is a S elevation showing the rear of the house. (Above-right) This is a detail photo showing the exposed beams that continue to the exterior of the house beneath the wide eave overhang of the shed roof. (Below-left) This is a S/E elevation showing the rear and left side of the house. Note the rear deck and wraparound, floor-to-ceiling windows at the corner. (Below-right) This is a perspective photo looking south from Center Street toward the house and its neighbor (center) at 510 Center. At the far left is a new intrusion – a barn-like shop building on its own parcel.

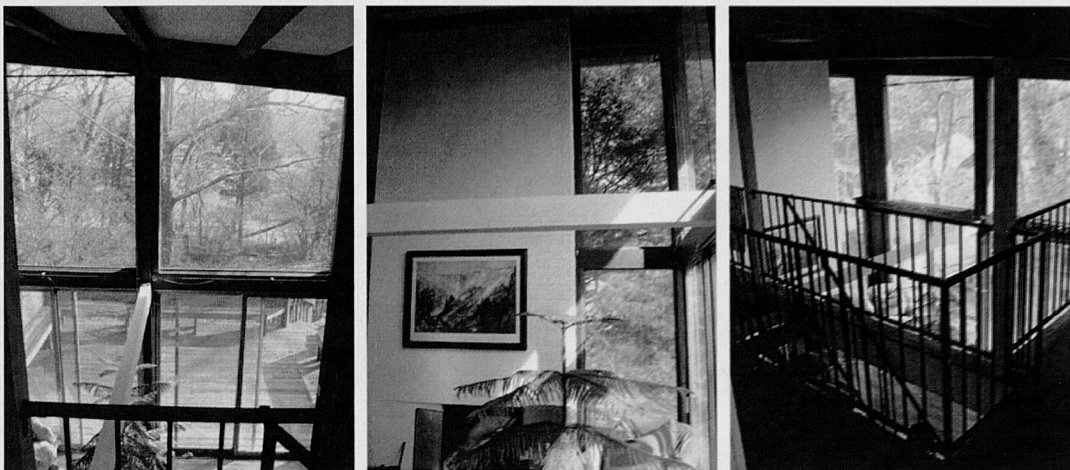
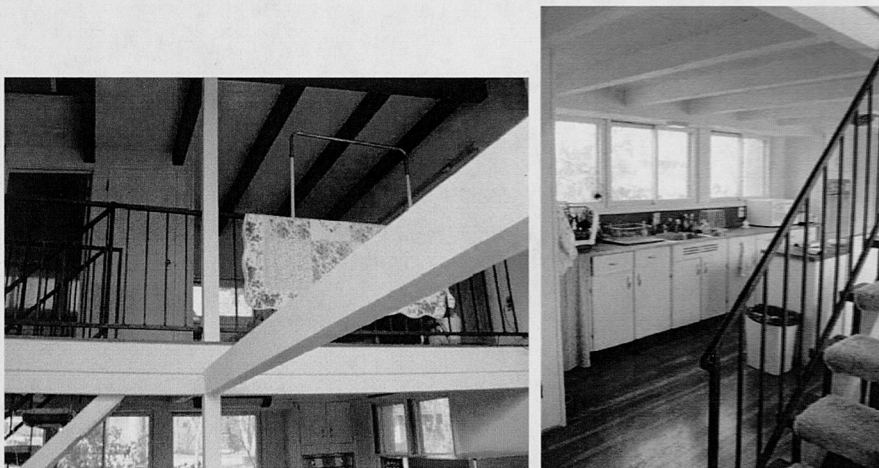
(Above-left) These are photos showing the dramatic, full height, wraparound floor-to-ceiling windows and glass doors on the S elevation (rear) of the house. The picture at far right above is looking from the Center Street "front" of the house (2<sup>nd</sup> story) toward the windows. (Below-left) This is a photo taken from the 1<sup>st</sup> story looking up toward the "loft" or indoor balcony space and the upstairs rooms. Also note the beam spanning the first story space in the living area. (Below-right) This is a detail photo looking from near the "front" door (actually in the right side) toward the kitchen.

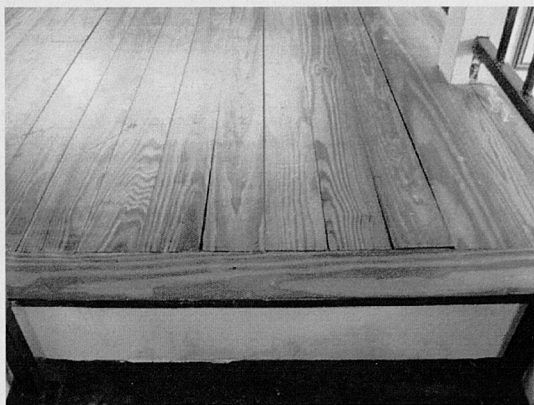
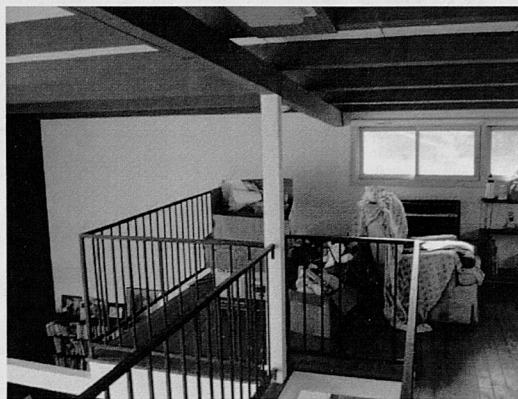
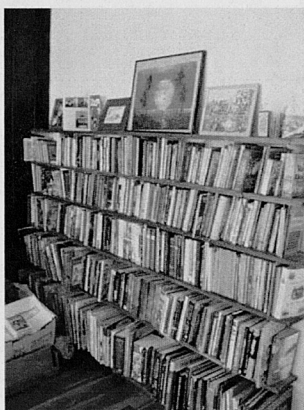
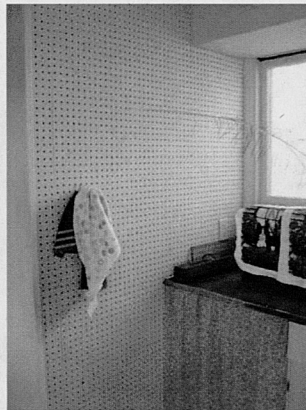
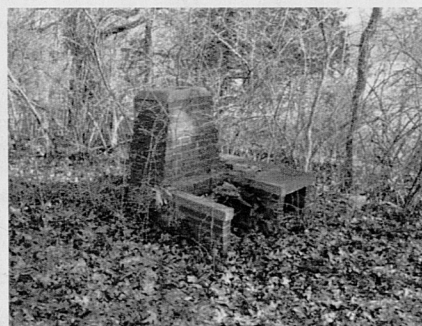
(Above-left) This is a detail photo of the original floors on the 2<sup>nd</sup> story. (Above-right) This is a photo taken on the 2<sup>nd</sup> story looking toward the right side of the house. (Below-left) This is a photo of what remains of bookshelves that extended up the full height of the wall at the side of the living room. (Below-center) This is the pegboard wall of the kitchen. Apparently, most of the interior walls were originally covered in pegboard. (Below-right) This is a photo showing the associated (1) outdoor fireplace in the back yard.
